WCS Engineering supports leading defence manufacturer to reduce costs, save energy, increase reliability and reduce chemical handling

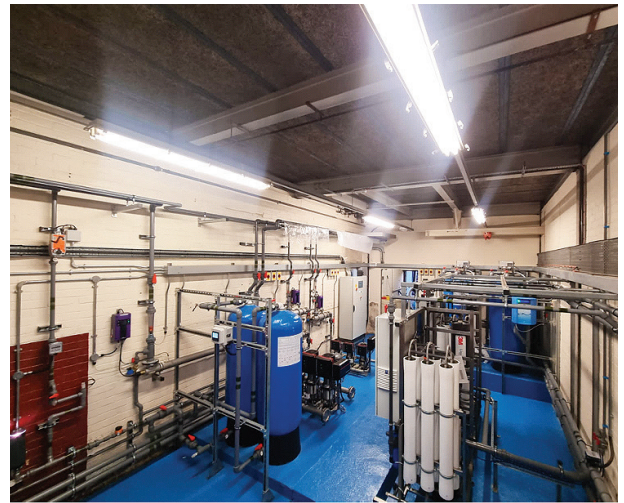
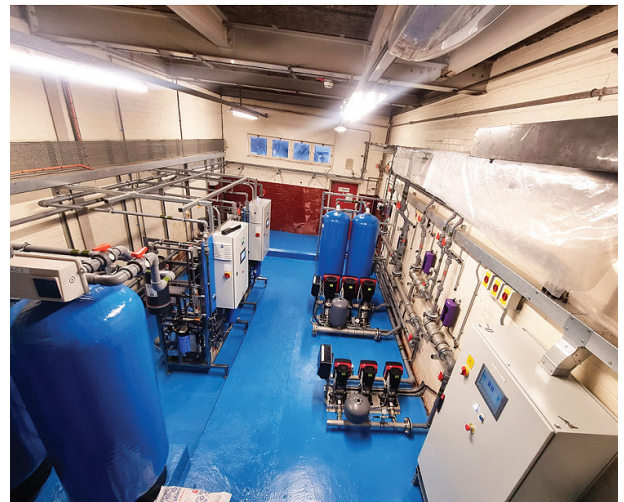
- New raw water break tank, sized at 6 m^3 , divided to enable easy cleaning
- Twin Electronic Deionisation (EDI) plants with associated pre-treatment, run on a duty/standby/assist basis
- One new 23 m^3 Demin water storage tank
- 1 new 10 m^3 RO water tank
- 1 new demin water circulation loop, with new circulation pump set
- 1 new RO water circulation loop, with new circulation pump set
- Blend system to convert demin water to RO water
- Polishing vessels on demin water circulation loop to ensure water quality to service
- Uv units on loops to ensure water quality.

By installing the new treatment process site were able to stop the use of both HCl and Caustic in the treatment process as the need for chemicals was removed.

Reducing the volume of stored treated water and the installation of the new ring mains with no dead legs has improved the bacteriological control on the whole system.

The installation of new booster pumps as drastically reduced the energy usage by the circulation pumps.
